THE PUQUIOS OF NASCA

Katharina J. Schreiber and Josué Lancho Rojas

Latin American Antiquity, 6(3), 1995, pp. 229–254.
Copyright © by the Society for American Archaeology

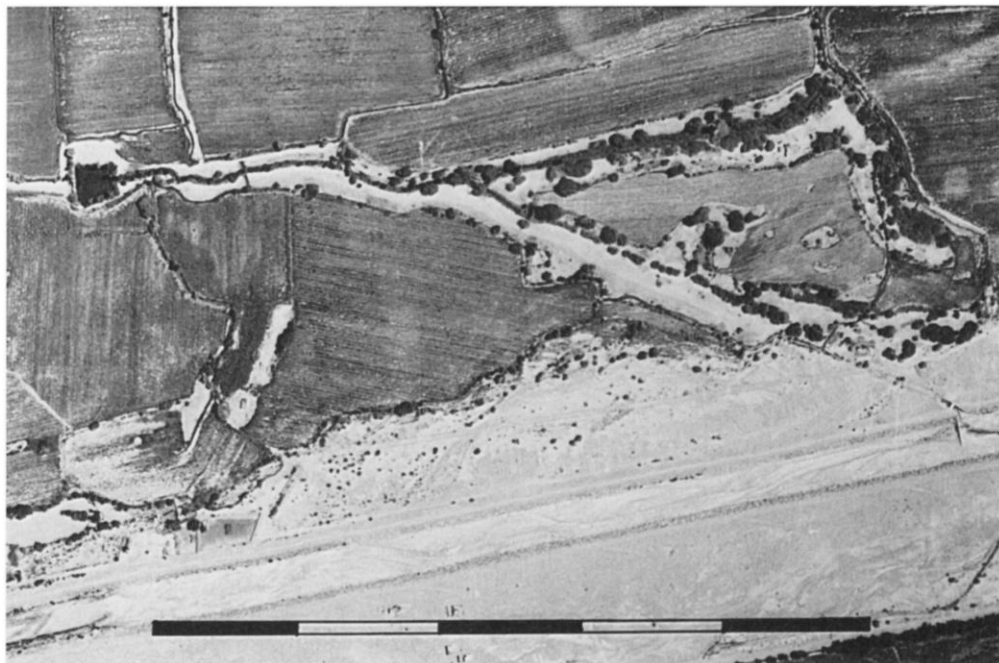
Figure 6. Aerial photograph of the puquio Wachuka taken in March 1970. The *kocha* is visible in the upper left corner. The puquio comprises two main branches: the southern branch is actually formed by one branch visible on the surface, and a second that extends under the riverbed with no surface traces. In this, and the following photographs, the scale represents 500 m; the photos are oriented with north at the top.

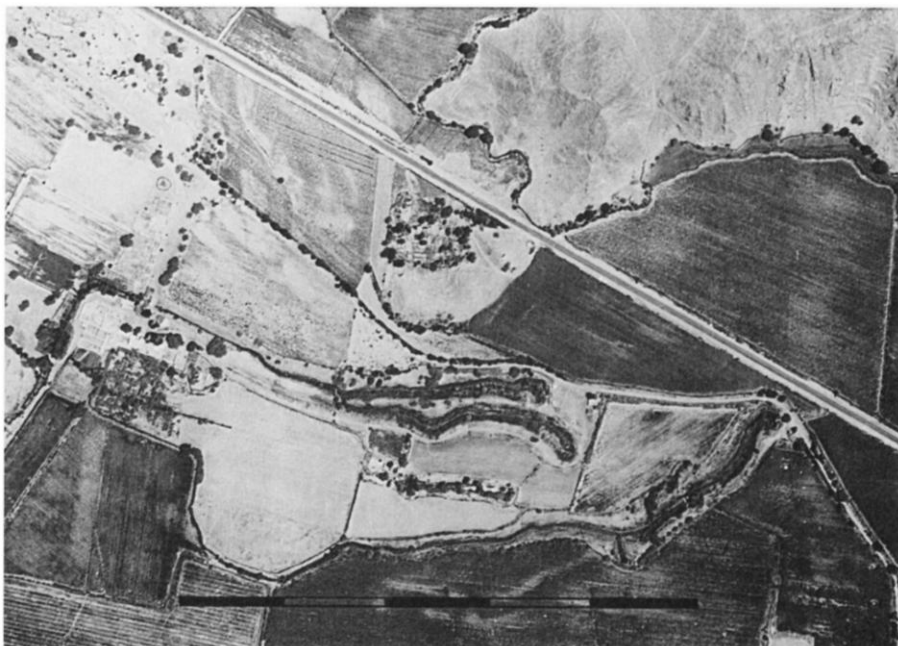
Figure 7. Aerial photograph of Achako taken in March 1970. Two large trenches join to form the northern puquio. The southern puquio is a very long trench that begins adjacent to the Pan American Highway; it is called “El Chico” because of its lower volume of water. Between the two is another trench that currently serves as a *pozo-kocha*; there are traces of a gallery that once connected it with the same *kocha* shared by the others. On the hillsides to the north-east are located settlements dating to the Late Intermediate Period.

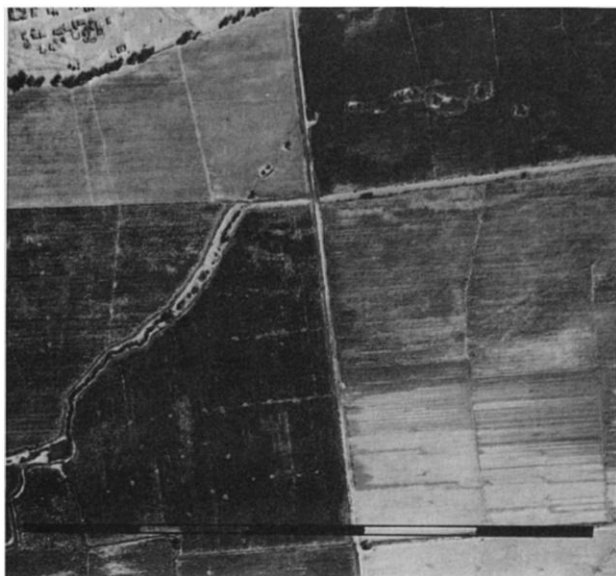
Figure 8. Aerial photograph of La Gobernadora taken in March 1970. The lower end of the puquio is open trench ending at a small *kocha*, visible near the lower left corner of the photograph. The middle section of the puquio is filled-trench gallery; portions have caved in and been left as open trench. The upper section of the puquio is tunneled gallery. Traces of an abandoned second branch can be seen just below the path that forms the field line running east-west to the right of the puquio.

La Gobernadora (Figure 8) is clear and functioning at present, but in 1934 González wrote that it was in the worst condition of all the puquios. The 1944 photos indicate that it had multiple branches, but all that is visible today is a single branch that begins as tunneled gallery, continues as filled-trench gallery and then open trench, and ends at a small, unimproved *kocha*.
